CASE HISTORY

New Zealand Earthquake Repair

PROJECT

Correct subsidence problems caused by earthquakes and level floor of house to meet building code requirements.

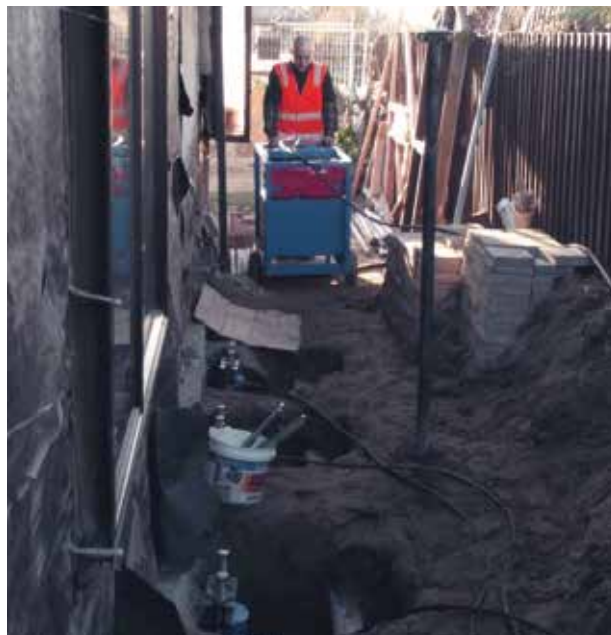
LIMITED TO 1.5 YARDS OF AVAILABLE WORK SPACE, INSTALLATION REQUIRED USE OF PORTABLE EQUIPMENT

Due to limited work space, the CHANCE Helical Piles were installed using a hydraulic drive motor. “We had to do a lot by hand, due to the tight spaces. That was our main challenges I assure you. We have done some commercial projects using a little Bobcat, but in this case we had to run hydraulic lines connected to a hydraulic drive motor.

The motor was designed to be on the end of a small digger, but we designed a torque bar and other equipment to make it work,” explains Hammond.
